AVIATION INVESTIGATION REPORT

A01O0164

IN-FLIGHT COLLISION

UXBRIDGE, ONTARIO

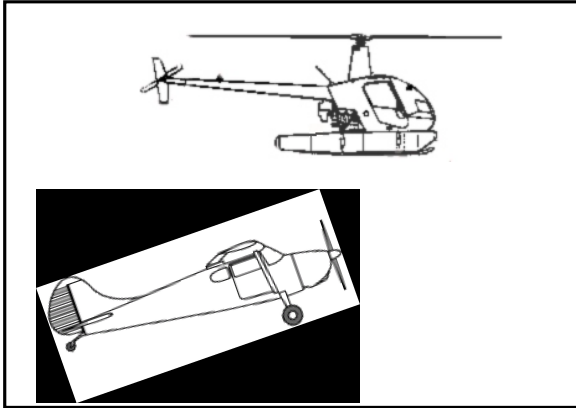
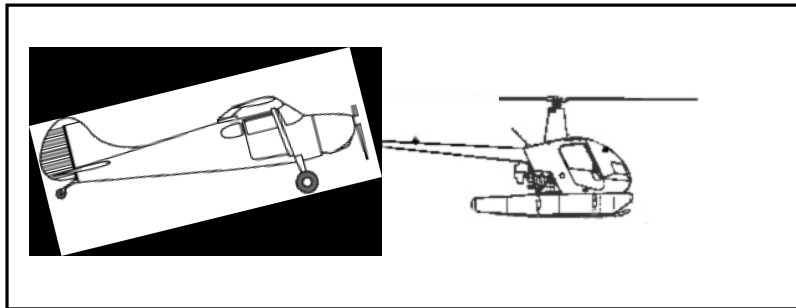
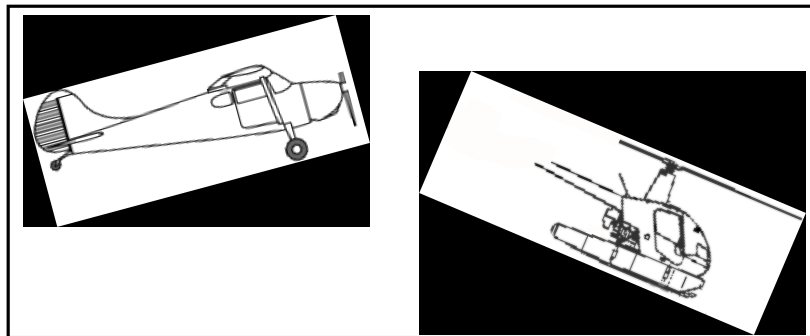
Appendix A—Impact Sequence

As the helicopter came into the Cessna pilot's field of vision, it was slightly above at the pilot's 11 o'clock position, at extremely close range. Collision was imminent, and although the Cessna pilot initiated a climbing right-hand collision-avoidance turn, he was unable to gain positive separation. The helicopter tail rotor struck the under side of the Cessna's engine cowl, and the tail-rotor blades broke. Simultaneously, the helicopter's retreating main-rotor blade struck the top left side of the Cessna's engine cowl, and the blade separated from the main-rotor system. The helicopter became uncontrollable and pitched forward to an inverted attitude. This pitching movement caused a bending moment of the remaining main-rotor blade. The blade flexed downward and severed the tail boom from the main body of the helicopter. The helicopter then descended to the ground and was destroyed by impact forces.
